ARTIFICIAL REEF MANAGEMENT PLAN FOR MARYLAND

Prepared By:
Andrew J. Loftus and Richard B. Stone
under
Maryland Environmental Service Contract 06-07-58

June 2007

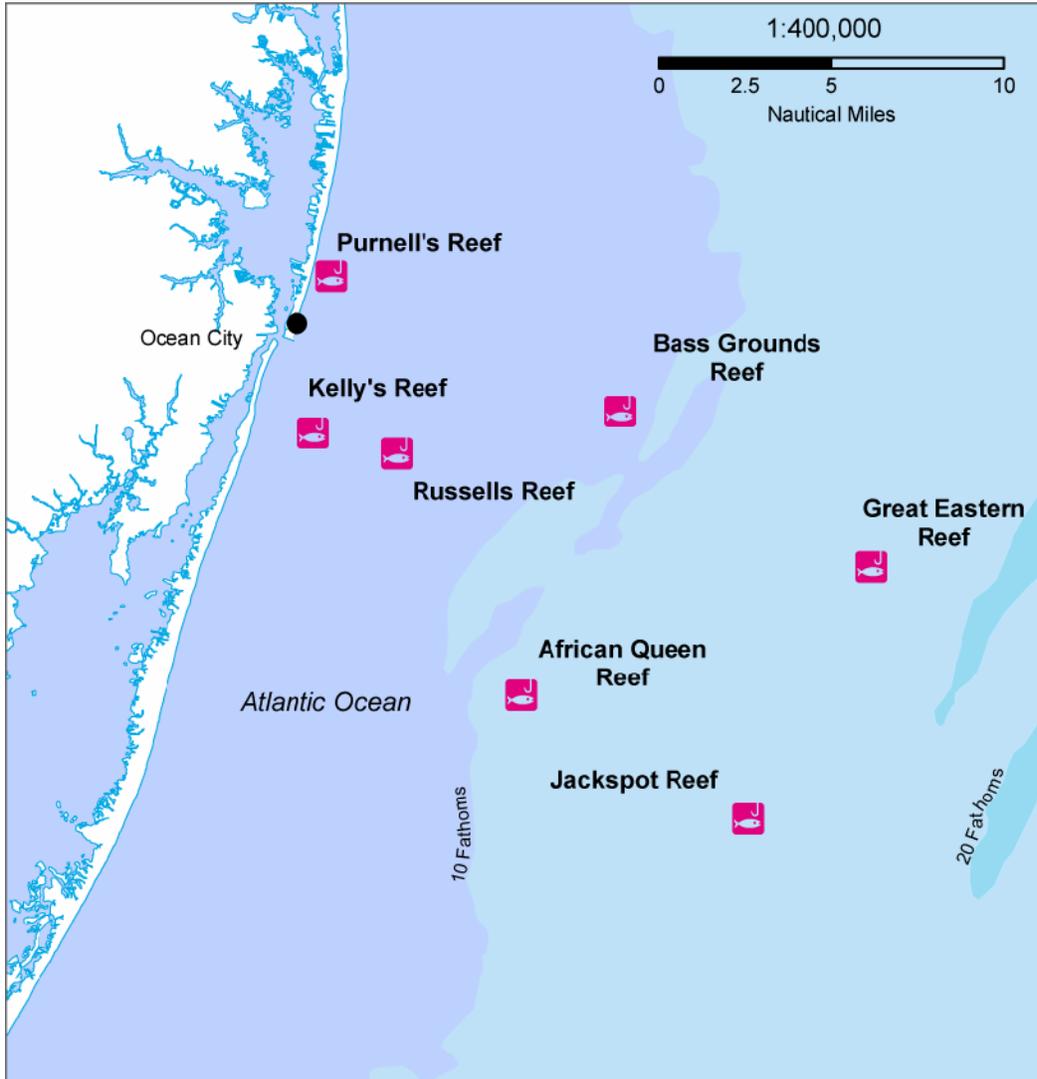
Figure 3. Maryland Ocean Artificial Reef Site Locations.

Note: "Research Reef" and "Isle of Wight" reef are not yet developed and are not depicted on this map.

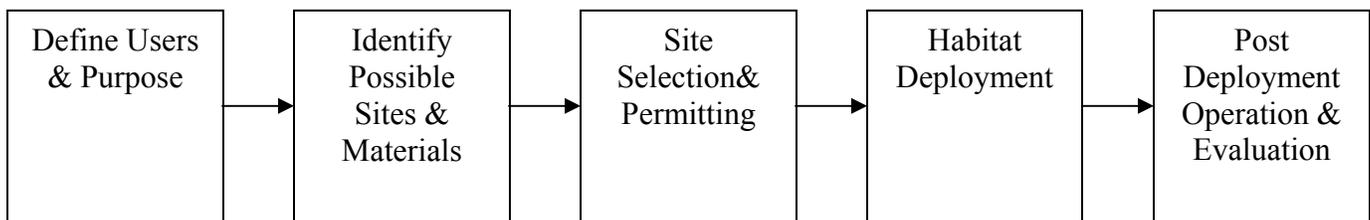
Figure 4. Sequence of Steps for Conducting Aquatic Artificial Habitat Projects.

This plan, including the “Decision Making Document for Artificial Reef Construction in Maryland” (Appendix A) is designed around this process, with Sections 5 and 6 of this plan embodying the primary components. Throughout all phases of development and implementation, it is imperative to include input from local interests who have local knowledge of the fisheries, bottom types, and other features effecting reef placement to ensure that the final product results in a reef structure that best meets the defined objectives.

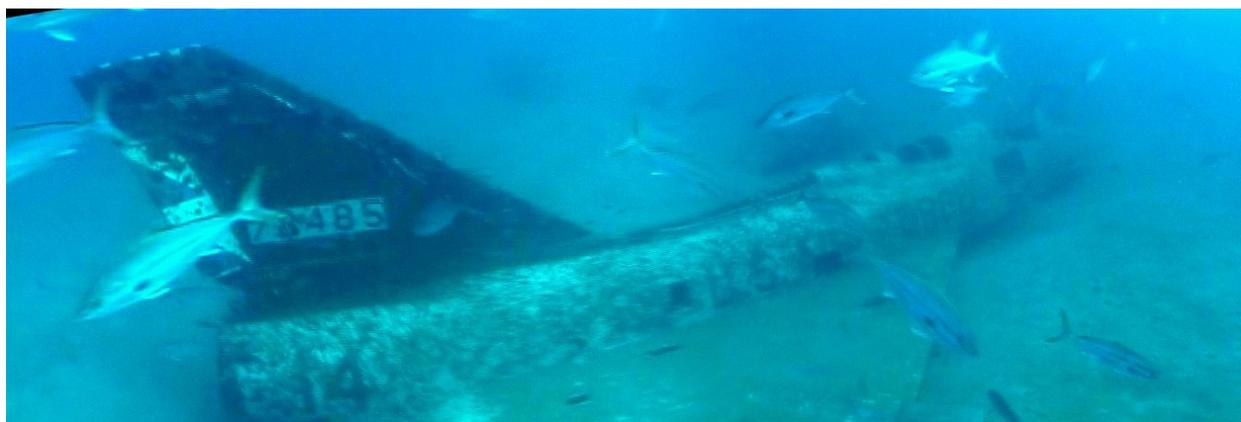
Several F-106 drone jet fighters deployed September 25, 1995, in 106-112 feet of water off Bay County, Florida, were visually evaluated in 1997 and again in 2001. The aircraft deployment was sponsored by the Tyndall Air Force Base Dive Club in cooperation with Bay County. Maher and Horn (1997) examined a single intact F-106 oriented upright on the bottom and originally deployed without the nose cone or engines. The plane was 65 feet in length, with a wingspan of 38 feet and a maximum vertical relief of 20 feet at the top of the vertical tail fin and a weight of approximately five tons. They reported 10 species of fish but relatively low abundances. Recreationally important fishes observed around the aircraft included greater amberjack, red snapper, gray snapper, gray triggerfish and scamp. Maher reported, "The thin aluminum skin of the aircraft was easily punctured by my finger and/or dive knife, indicating that some oxidation had occurred." Maher and Horn (1997) stated that the plane had "a well-developed bio-fouling community consisting of predominantly encrusting soft sponges." In November 2001, a second assessment was made of two F-106 drones from the original 1995 deployment (Mille and Horn 2001). Both aircraft observed were intact and at the location of the original reported deployment despite having been exposed to Hurricane Opal in October 1995 and Hurricane Georges in September 1998. The observers noted little degradation of the aircraft. Ten fish species were noted. In excess of 100 greater amberjack were recorded. Other recreationally important fish recorded in lesser numbers were gray snapper, gag, scamp, and red snapper. Bio-fouling levels on the aircraft appeared to vary with the surface area location and orientation of the aircraft.

Thirty Navy A-6 Intruder fighter aircraft fuselage sections were deployed off St. Johns County in 104 feet of water in June 1995. A review of video footage taken one month post-deployment indicated that the majority of the aircraft components were sunk within a 250 foot diameter circle. The video confirmed that plexiglass canopies were left in place, and on at least one aircraft, fish were getting inside the cockpit canopy and unable to escape. Fish species documented in the video included barracuda, amberjack, and round scad. Grouper and snapper species were not seen at that

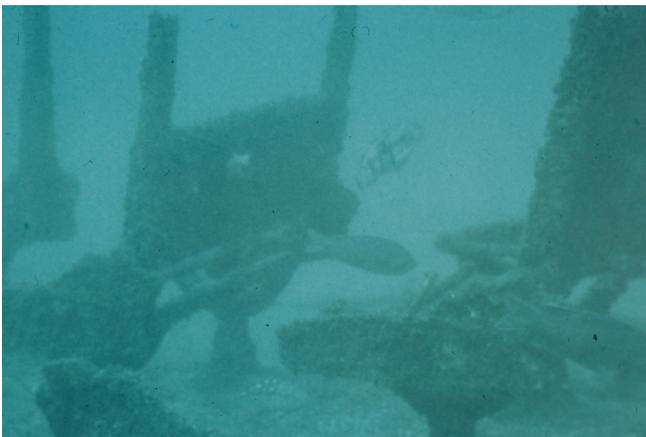
Steel Railroad Hopper Cars

The Lee County, Florida metal hopper cars were inspected after approximately 2.5 years following the 1994 deployment. The group of 16 cars that were stacked in 90 feet of water did not show any signs of structural damage or weakening of the welds due to hydrodynamic or other forces. The reef was very productive, providing habitat for large goliath grouper, gag, and large schools (100+) of gray snapper. A total of 19 species was identified on the reef. Observations indicated that the stability and complexity of this type of reef material was moderate to good, while durability is thought to be

moderate. The metal walls were showing signs of corrosion, particularly around the holes which were punched to increase water flow through the units. However, after 2.5 years, corrosion was present only on the surface of the metal, not yet affecting its strength.

these individual units. This would be expected due to the smaller profile and footprint of these individual units. It was observed that some of the welds at the corners of the cars were cracking; however, it is not known to what degree this will affect the structural integrity of the units. Based on the observations, an hypothesis was developed that the individual hopper cars were subjected to greater hydrodynamic forces per car, compared to the stacked units in which the currents/surges were deflected by the various angles of metal and thus reduced in force. That evidence has led to the conclusion that any future deployments should stack rail cars, rather than deploying them as individual units (Tom Maher, personal communication).

The hopper cars were visually inspected by Lee County artificial reef staff in December 2001. Most of the hopper cars were still intact with the main pile of cars showing good integrity. However, there were some individual cars that showed loose, flapping sides and others with sides missing completely. Fish population levels were still classified as good with schools of very large crevalle jack and barracudas. Goliath grouper were also present. In early March 2002, the Lee County reef coordinator fished the site and caught his bag limit of 14-18 inch long gray snapper (Chris Koepfer, personal communication). The "Charlies #1" 90 feet deep hopper car pile was inspected on April 21, 2003, nine years post deployment. Gaping corrosion holes had appeared in the metal sides of the cars, resulting in the physical loss of about 50% of the side plating surface area of cars either through corrosion, or physical loss of metal plates. Bare frames were exposed. Fouling on the remnant metal on the sides was light because of the layers of metal sloughing off. The stacking of the cars still provided some complexity. (Chris Koepfer, personal communication). Twenty one fish species were noted under conditions of 50-60 feet of visibility in 72 degree bottom temperatures. Scamp, greater amberjack, gray snapper, and lane snapper reported as common (20-99 specimens each) and yellowtail snapper were observed as frequent (11-20 specimens). A Lee County Fish Census Field Report in 2003, monitoring a railroad hopper car site, also noted several Goliath grouper.

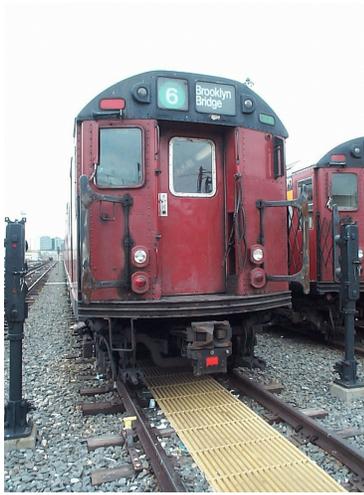
In 2001, the New York City Transit Authority (NYCTA) offered 1,300 obsolete subway car shells to state programs as reef material. The NYCTA offered to clean and transport the cars. These cars, dating from the late 1950s and 1960s, weighed 9 tons and were 9 feet wide, 9.4 feet high, and 51.5 feet long. They were composed of sheet steel 0.07 inches thick. A small amount of non-friable asbestos was on the walls between two layers of steel.

Both the New York and Philadelphia regions of the EPA provided guidance on the asbestos issue. The asbestos was found in a small quantity and was bound in a solid matrix (non-friable). There was no mechanism for detrimental effects to the marine environment. The Philadelphia office of the U.S. Army Corps of Engineers and the NMFS supported the use of these cars as reef material. Bill Muir of the EPA, after examination of the submerged New Jersey subway cars and NYCTA transit cars, projected a 25 to 30 year life for the material underwater.

With the asbestos and durability issues addressed, Delaware signed an agreement to accept 400 subway cars from the NYCTA. The agreement was later amended to include 1,100 cars. As of 2003, 517 cars have been deployed in 85 feet of water on one Delaware site. The cars support an invertebrate assemblage and dense populations of seabass and tautog.

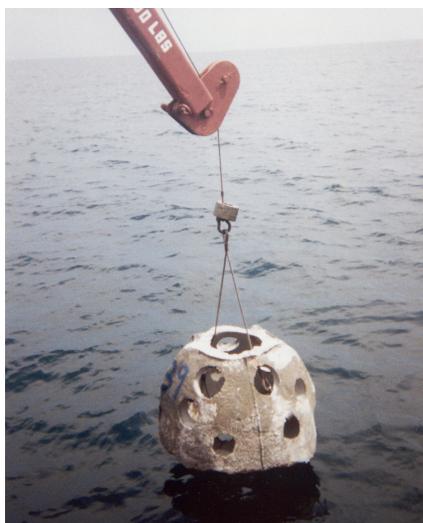
Early versions of designed reef structures largely relied on secondary use materials, such as tires, in their designs and were necessarily configured to accommodate these materials. Some of the earliest designed reef structures constructed for fisheries enhancement include 4'x4' log huts built and deployed by South Carolinians in the late 1830s to improve fishing for sheepshead (McGurrin 1988) and bamboo frames filled with sand bags and other materials to improve catches of grunts off the Japanese coast (Vik 1985).

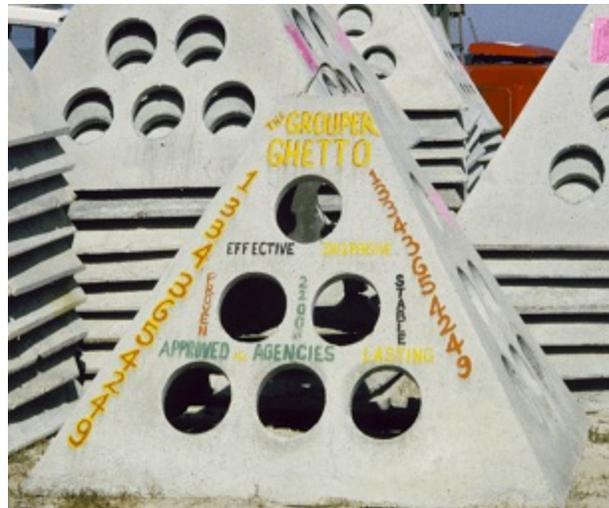
Maher (2001) located 44 different modules that had been designed or patented in the United States; although, only 31 designs had actually been deployed. Of this total, several designs were used only on a limited basis for specific research studies and mitigation, while others are no longer produced. Several structures are commercially available, while some represent program designs, either for research, construction, or both. Maher’s survey in June, 2001, indicated that over 31,000 designed structures had been deployed along the eastern seaboard, in the Gulf of Mexico, and off Puerto Rico. To date, most designed artificial reef structures deployed in the United States have been relatively small (19 to 70 cubic feet in volume) and are made from readily available, durable materials such as concrete or steel fashioned into domes, tetrahedrons, pyramids, cylinders, squares, and other shapes. Examples of these designs are found in McGurrin (1988), McGurrin and Wilson (1991), and Maher (2001). One study evaluated the use of plastic cone-shaped artificial reef modules in a northwest Florida bay environment (Bortone et al. 1994).

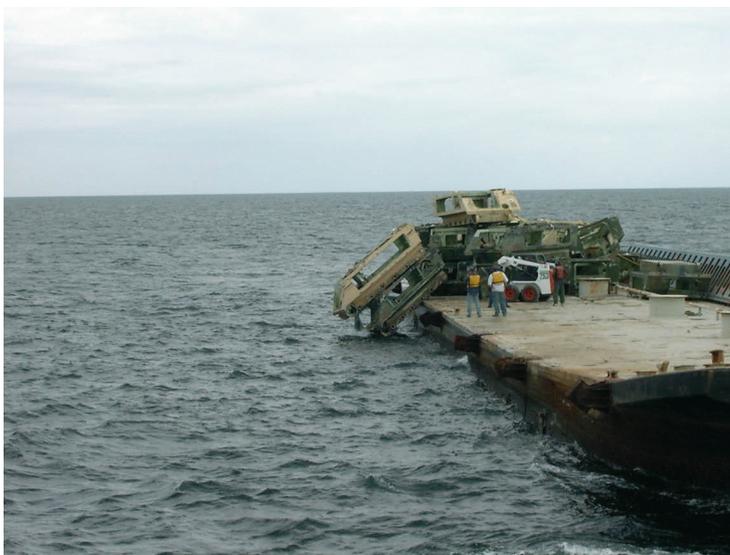
Tanks lowered by crane during REEFEX '94 included six off Alabama and two off Miami-Dade County (Southeast Florida). The six Alabama crane deployments resulted in all six tanks either being flipped on their sides or upside down when the lifting slings apparently snagged as they were pulled out from under the tanks by the 800 ton crane. Two tanks lowered by crane in Miami-Dade County were placed in an upright position. Divers removed lifting straps so they would not hang up on the tanks and the tanks remained in their upright position. (Jon Dodrill, personal communication).

In Florida, off Pasco County, while viewing an upright tank that had not subsided two years post deployment, artificial reef program staff noted the collapse into the engine compartment interior of a fire retardant material lining the ceiling of the engine compartment (Maher and Horn 1997). This breaking loose and collapse of the engine compartment ceiling shroud was noted on several tanks deployed off Florida (Jon Dodrill, personal communication).

An analysis of video taken topside combined with visual observations of the initial Florida tank deployments that resulted in tanks landing upside down suggested that the tanks were being pushed too slowly over the edge of the barge. At the point the tank reached the edge of the barge, the forklift stopped aggressively pushing straight ahead and the tanks lost forward momentum. The MBTs were slowly eased over the edge of the barge, tipped straight down and entered the water vertically. They subsequently flipped upside down during their free fall through 80-90 feet of water. Later tanks were pushed more rapidly and steadily off the barges and not lifted up in the rear by the forklift. Tanks deployed in less than 50 feet of water also appeared to land upright with greater frequency (Jon Dodrill, personal communication).

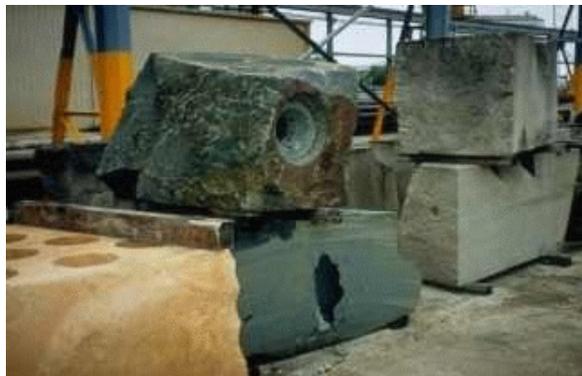
Florida limestone artificial reef projects typically utilized boulders with a density of 140-145 pounds per cubic foot (cpf), ranging from two-six feet in diameter (1,000-12,000 pounds) that either originated from existing quarry operations within the counties where the reef projects were undertaken or were trucked in from adjacent counties. Boulder deployments have been performed using hopper barges where the bottom opens up and the load of boulders is deployed at once, single boulder placement with the use of crane, or through the use of a front end loader pushing boulders off the barge. Crane placement and rapid hopper barge bottom drop deployment have resulted in tight well controlled placements of boulders. Varying size and shape of boulders create a reef structure of complex habitat with interlocking components that have demonstrated resistance to storm activity (Carmen Vare and Brian Flynn, personal communications).

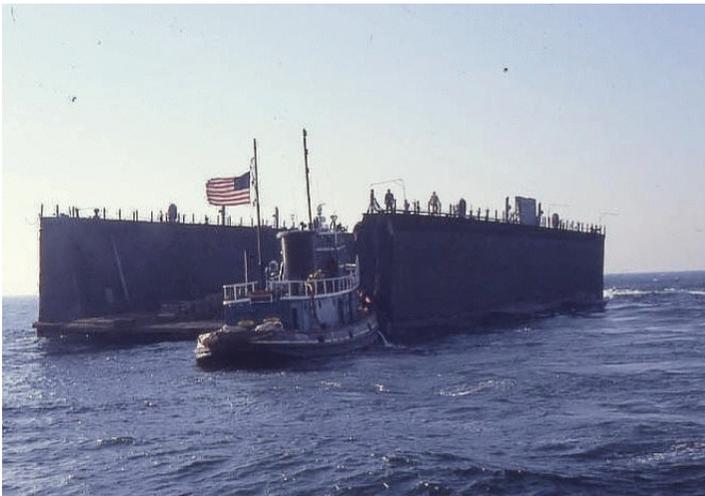
Dry docks have been utilized as artificial reefs off Alabama, New York, Virginia, and northeast and southeast Florida. Dry docks were readily accepted as reef material in New York's artificial reef program. The structures used were 30 to 50 years old, made from treated yellow pine, had significant steel components, and were considered stable with a 20 year estimated lifespan. Sonar surveys of three drydocks within ten years of deployment showed some deterioration, including collapsed wing walls. Complaints were received from trawlermen about catching

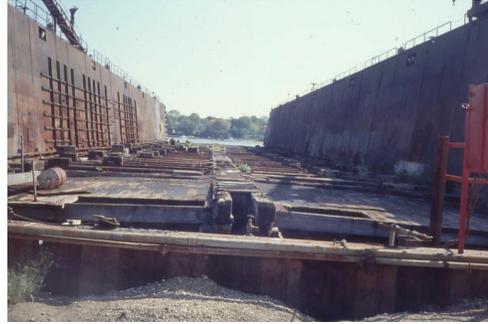
The tremendous resistance offered by the surface area of the wing walls of a large dry dock, and the impacts of strong current and surge activity of a major storm event on these structures is illustrated by the response of a large dry dock off Jacksonville, Florida, to a hurricane event. The U.S. Navy donated the steel dry dock, which was 615 feet long, 127 feet wide, and 57 feet tall, and it was sunk as an artificial reef off Jacksonville, Florida. At that time, it was one of the longest structures ever sunk on the Atlantic Coast as an artificial reef. The dry dock sank in 20 minutes in 125 feet of water without the use of explosives on Sept. 13, 1989. Following the passage of Hurricane Hugo shortly after its deployment, the dry dock was noted to have shifted its long axis orientation from 330 degrees to 20 degrees, and both of the massive 13 foot thick wing walls had separated at the base and fallen over. Several years later, even with wing walls collapsed, the structure was still considered by locals to be a successful artificial reef, attracting a variety of marine life (Berg and Berg 1991, Rinehart 1991, Virginia Vail, personal communication).

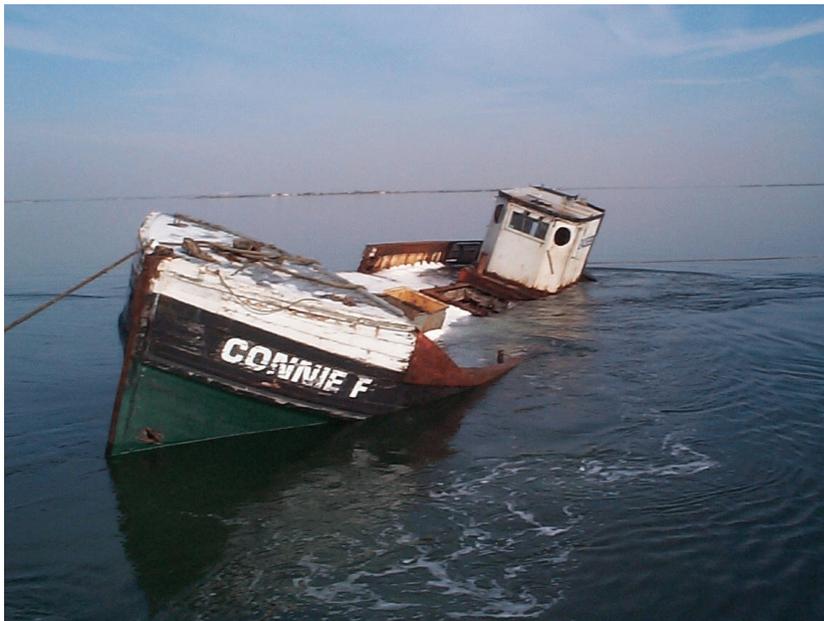
2.9.4 Wooden Vessels

The general history of wooden vessel use as artificial reefs shows that only the heavier metal components of the vessels have durability, while the rest of the wreck eventually falls to pieces as the result of storm activity, boring worms, and other marine organisms. The 80 foot, wooden-hulled, square masted Schooner, *Lady Free*, sunk off Dade County, Florida in 1986, began to deteriorate after the first winter, and, by 1991, was unrecognizable except for an engine block. A second wooden boat was scuttled on this same site in 1990, and, within one year, it was observed to be rapidly deteriorating. A wooden motor yacht, *Lewis Marine*, sunk off Broward County, Florida in 75 feet of water in 1986, resulted in scattered rubble around an engine block by 1990 (Berg and Berg 1991). Wooden fishing vessels as large as 40 to 55 feet in length, sunk within a quarter of a mile offshore Cape Hatteras and Cape Lookout, North Carolina, were reportedly scattered along the beach in pieces after one week (Jon Dodrill, personal communication). Old wooden menhaden fishing vessels exceeding 150 feet and intentionally sunk as reefs, have had entire portions of the wooden deck tear loose after a short period of time (DeWitt Myatt III, personal communication). Old wooden ferry boats, employed as artificial reefs in waters off New York, deteriorated very rapidly, while other, more substantial vessels have persisted much longer (Steve Heins, personal communication). The planking and superstructure of a wooden-hull vessel, sunk in the early days of Georgia's artificial reef program, disintegrated within two years, leaving only the ribs, which lasted some time longer (Henry Ansley, personal communication).

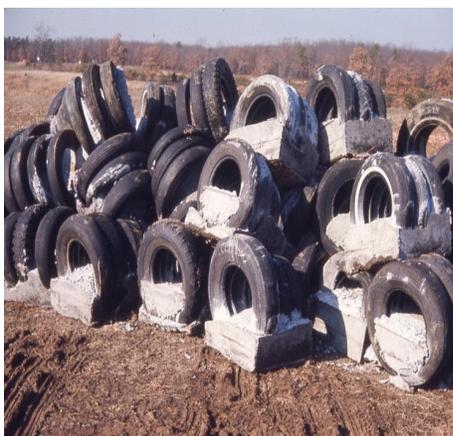
Individually Unmodified and Un-ballasted Tires Incorporated into Designed Concrete Reef Modules

One designed module presently in use in Alabama since 1998 is a 10 foot tall concrete tetrahedral frame with ten individually un-ballasted automobile tires slipped over each of six legs of the module prior to joining the individual legs together (Walter 1998). The stability of the un-ballasted tires is dependent upon the durability, stability, and overall longevity of the concrete module frame upon which a total of 60 tires per unit are strung. The total dry weight of the module with and without tires was estimated at 2.4 and 1.8 tons, respectively. The module's submerged weight with and without tires was estimated at 1.1 and 1.0 ton, respectively. An engineering evaluation of the structure found that the

module without tires is generally more stable than that with tires. For a 20-year storm event, the study recommended placement of modules with tires at depths of 75 feet or deeper, and placement of modules without tires at depths of 50 feet or deeper to avoid movement in a 20-year return interval hurricane event (Paul Lin and Associates 2000).

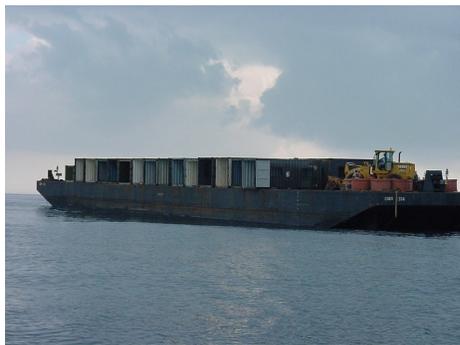
In the autumn of 2001, approximately 100 steel shipping containers measuring 20 feet long, 8 feet high, and 6 feet wide were donated to the South Carolina Marine Artificial Reef Program. The State decided to utilize the containers on an experimental basis in order to monitor and assess their effectiveness as reef material. It was estimated that the corrugated steel container boxes will function in a manner similar to the steel railroad boxcars which have been used in several states along the East and Gulf coasts, as mentioned earlier in this document (Section 2.6).

To prepare the containers, end doors were welded open and holes were cut into the remaining sides to allow water flow through the units and, hopefully, reduce the stress of currents on the container walls. The containers required little additional cleaning since they are nothing more than large steel boxes. They were deployed on three reef sites of 50, 60, and 80-foot depths. Evaluations after one year under water revealed that approximately 90% of the containers remained intact and upright on the bottom. Marine growth was evident on all interior and exterior surfaces and large numbers of gag, scamp and red snapper were in and around the units. Ongoing monitoring will continue to measure durability and stability of the units at different depths, as well as biological colonization and recruitment on the material.

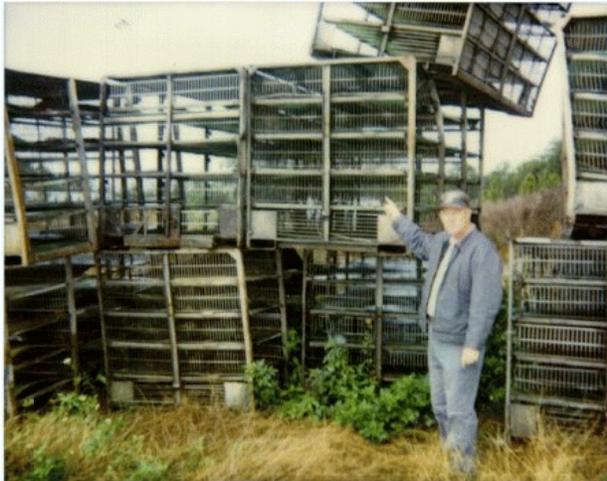
Georgia deployed approximately 400 Chicken Transport Units (CTUs) at two estuarine artificial reefs in the early 1990s. They were placed on the intertidal sites in clumps of four.

The reefs were sited according to the inshore program's siting criteria, and the cages are fully colonized and covered with oysters. At one of the reefs that was not sited by program personnel, the cages have subsided in to a great degree; however, the exposed portions still support good oyster growth. All cages that were deployed in the 1990s remain intact.

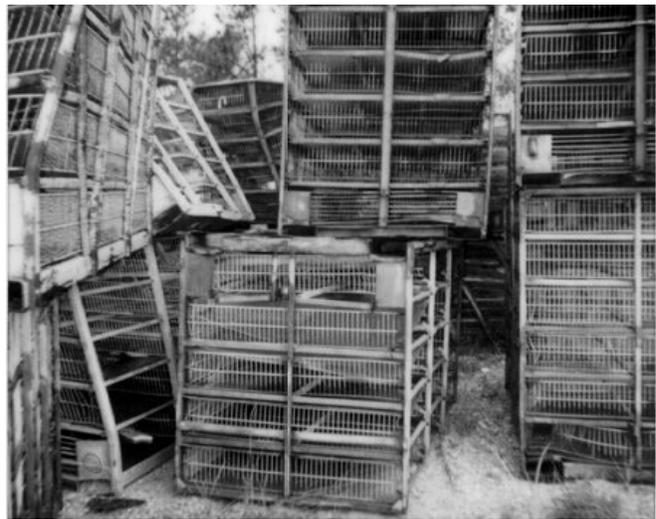
In northwest Florida, miscellaneous materials, including CTUs have been utilized by private citizens in cooperation with the local coastal government artificial reef programs off Bay, Okaloosa, and Escambia Counties. These devices were formerly used to cage and transport poultry by truck. At the end of their operating lives they are shipped from various locations, some out of state and are sold to fishermen in Alabama and northwest Florida. Three western Florida panhandle coastal counties maintain multi-square mile artificial reef sites in federal waters and have formal reef material inspection programs to assist private citizens and charter captains wishing to deploy private artificial reefs. CTUs and other miscellaneous materials go through a county inspection program. Any fiberglass flooring has to be removed from the CTUs and at least two units have to be chained or cabled together prior to deployment as reefs. Inspected and approved materials are documented on a signed inspection/cargo manifest which is carried by private individuals who are authorized to transport the reef materials offshore for placement in the county permitted areas. Since the mid-1990s CTUs have been deployed to northwest Florida Large Area Artificial Reef Sites (LAARS) by private recreational fishermen and charterboat fishing captains. In Okaloosa County during the period July 2001 through September 2002, 44 private reef deployments were made of which 20 (45.4%) used a total of 240 CTUs. The remaining 24 inspected private reef deployments were dominated by miscellaneous steel items, primarily welded rebar or angle iron frame steel cages, often wrapped with heavy gauge fencing. Also included were concrete mixer drums, heavy steel wire wheels chained together, heavy wire rolls and an old metal boat trailer.

By late 2002 the privately deployed materials off Okaloosa County were represented almost exclusively by CTUs. From December 2002 through April 2003, of 38 private reef deployment inspections, 35 (92%) were conducted mostly or entirely on CTUs and included a total of about 504 CTUs. Other county approved privately deployed materials included six welded pipe frames, 4 steel
